IN-DEPTH CATHODIC PROTECTION  
SYSTEM INSPECTION AND RECOMMENDATIONS

MAY 2004

LACEY V. MURROW BRIDGE (90/25S)  
HOMER HADLEY BRIDGE (90/25N)

PREPARED BY:  
HARDESTY & HANOVER, LLP • CONSULTING ENGINEERS  
NEW YORK, NEW YORK  
&  
CONCORR, INC.  
STERLING, VIRGINIA

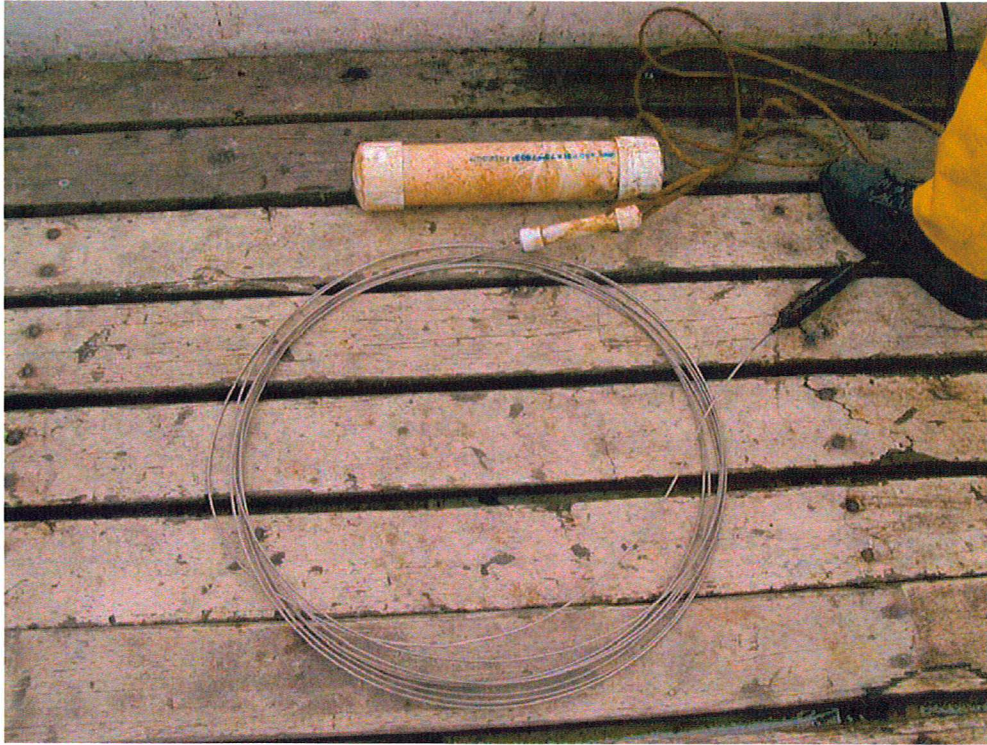
Figure A-2: Retrieved Anode Coiled for Measurement

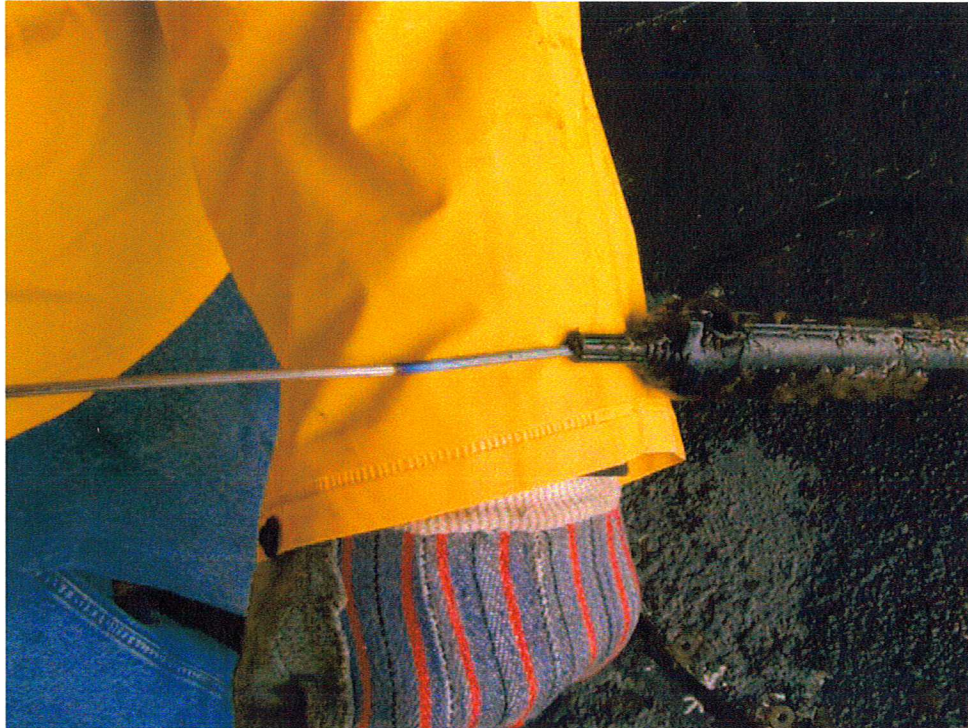
The detailed results of the visual survey are presented in Table B-1 in Appendix B. Almost every anode exhibited some form of degradation or failure. Accelerated consumption of platinum at the top of the anode, just below the endcap was prevalent (see Figure A-4 of the Appendix A). This is attributed to excessive current density at this location. Similar damage was also observed at the bottom of the anodes. The anode of Zone JL6N had failed at an intermediate length. The cause of failure was not investigated. The condition of many of the endcaps was not satisfactory. Some had started to deteriorate and water was penetrating inside the caps. In some endcaps the mechanical crimp is extending outside the endcap and water can easily penetrate inside it (see Figure A-5 of Appendix A). In general, the quality of the endcaps is considered to be poor considering the environment it is to be used in. Water penetration inside the caps can result in failure of the connection due to corrosion of the copper in the crimps. The length of the cables varied from one anode to another. It is not known if the varying

Figure A-4: Typical Coating Damage at the Endcap

1. Adjust the length of the rope holding each anode to raise the top of the anode wire to just below the pontoon bottom.
2. Replace all missing and damaged anodes within the next 12 months with alternate titanium anode design provided in Appendix C.
3. Repair or replace the following rectifiers:
  - a. Zone DS of LVM Bridge
  - b. Zone LS of LVM Bridge

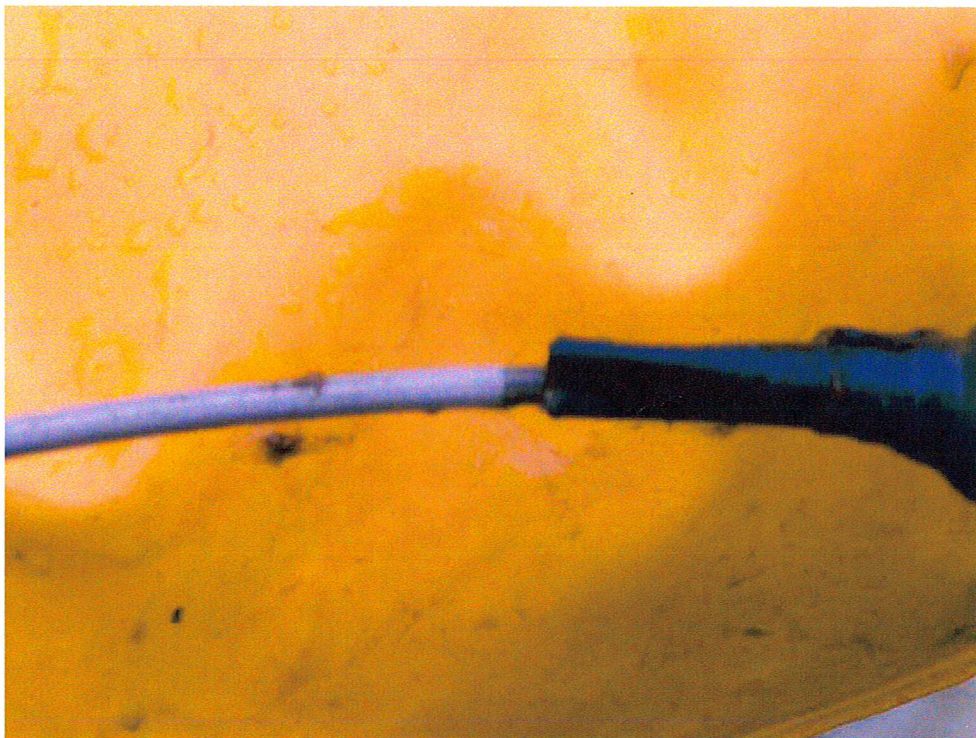
Figure A-5: Crimp Outside the Endcap
